# Science Data Report for the Optical Properties Monitor (OPM) Experiment

*D.R. Wilkes and J.M. Zwiener*  
*AZ Technology, Inc., Huntsville, AL 35806*

Prepared for Marshall Space Flight Center  
under Contract NAS8-39237

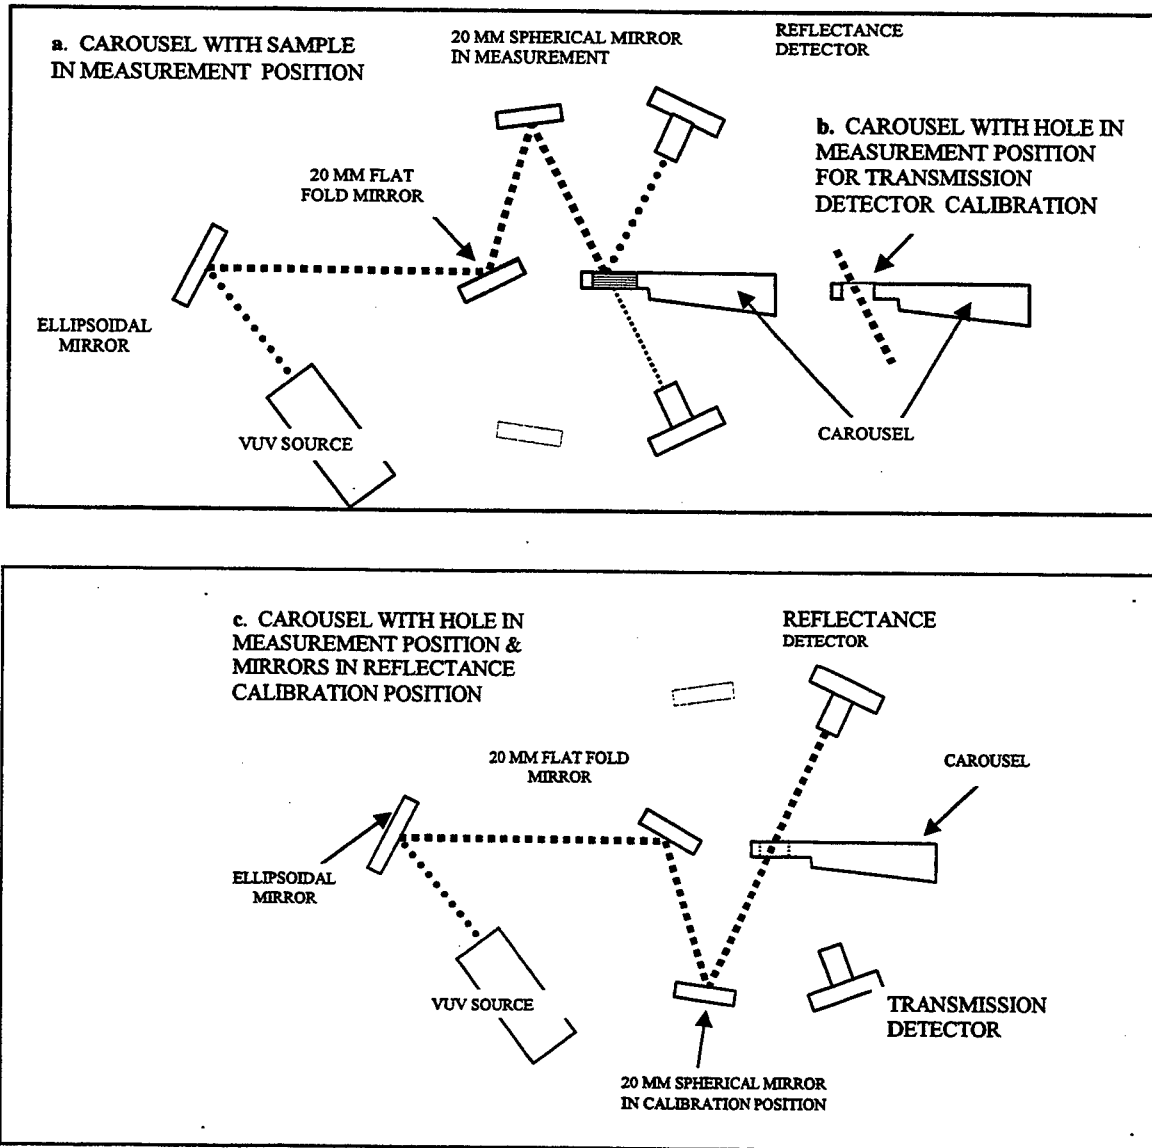
Figure 2-20. Operational Schematic of VUV Specular Reflectometer (not to scale)

The light source used for the VUV instrument was the V05 Deuterium Arc Lamp manufactured by Cathodeon, LTD. This lamp was an arc lamp complete with an anode, cathode, and heater. The heater heated up the cathode prior to the anode being struck. Once the cathode was heated, the anode required a high voltage strike to turn the lamp on. The lamp produced UV light in the wavelength range of 121.6 - 250.0nm.
